REPORT

from test No. 1/LL/179/2017/A

**Subject: Technical study of luminary enclosures
type Secure LED 26W 3800LM**

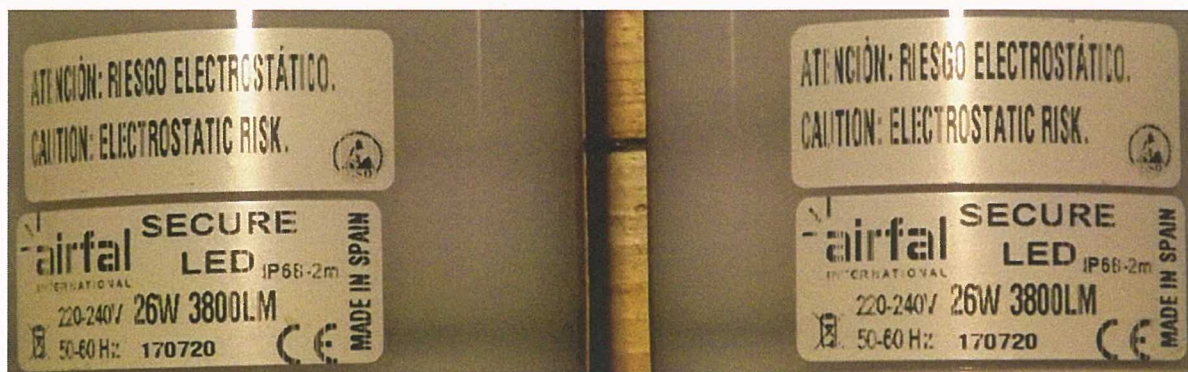
Picture 2. Tested luminary enclosures nameplates

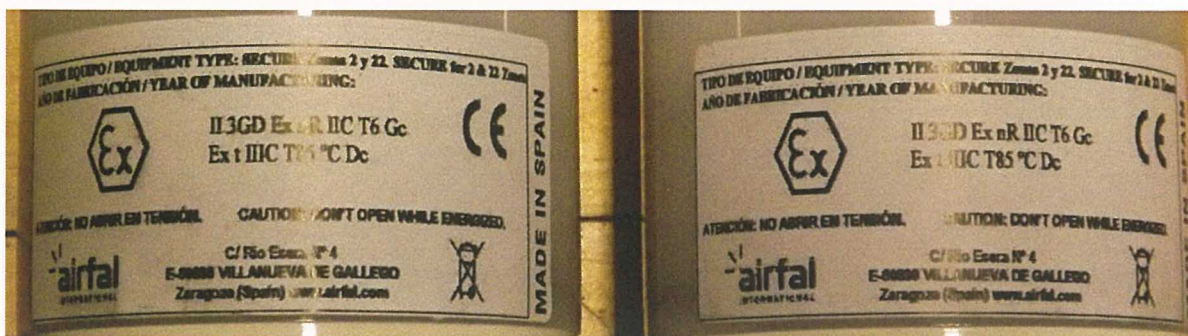
Picture 3. Determination of the type of construction of tested luminaries

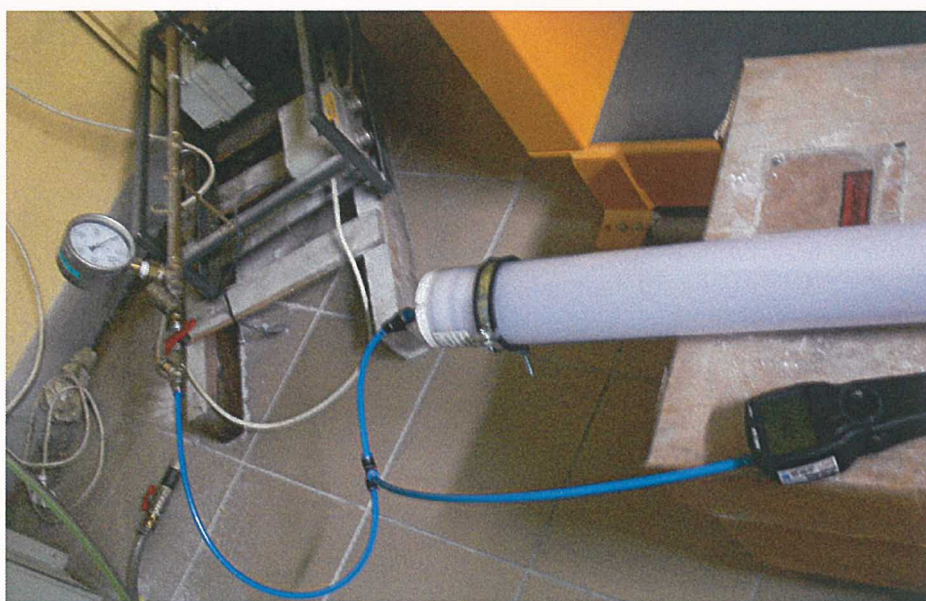
Test performed with underpressure of 0,3kPa inside the enclosure.

Enclosure marked	Underpressure applied [Pa]	Underpressure gained [Pa]	Duration [s]
A	300	156,4	180
B	300	211,8	180

Tested enclosures meet the requirements of clause 22.6.2.2 of PN-EN 60079-15:2010.

Picture 4. Tested enclosure during tightness test
